OH-58 Pilot Display Unit (PDU) Simulated Crash Tests

December 1994

**United States Army Aeromedical Research Laboratory
Fort Rucker, Alabama 36362-0577**

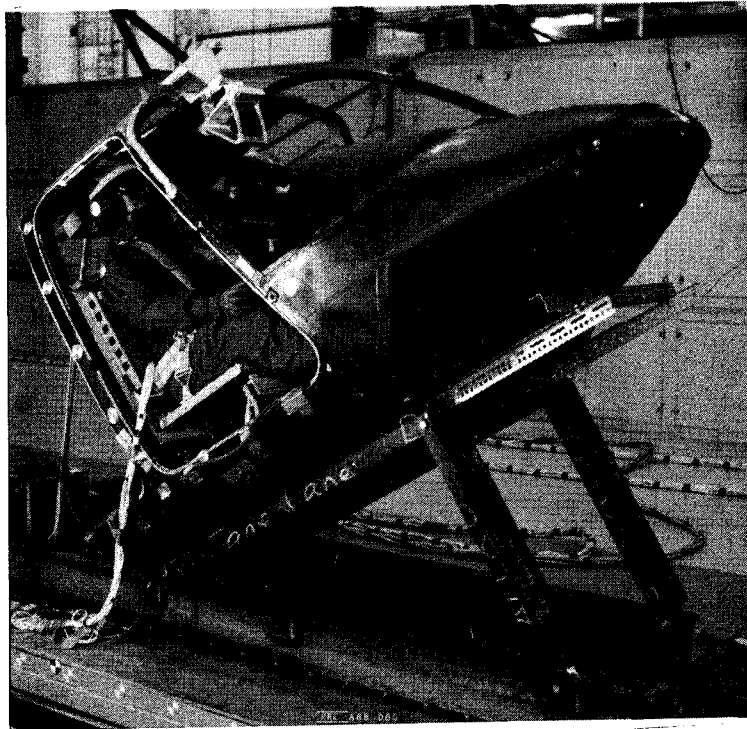
The setup for test 88060 is shown in Figure 4. As shown in Table 1, this test simulates a pitch down crash in which the vertical force is slightly greater than half the forward force. At 500 G/sec acceleration onset and 15-G peak combined with only 23.5 fps velocity, the impact was of moderate level. As shown in Table 3, the neck tensile force of 444 pounds and 613 inch-pound moment about the lateral (y) axis is about half that of the values in test 88063. The force transfer into the PDU ½-inch ENSOLITE™* foam from the helmet impact did not register on the neck load cell or the head accelerometers.

Figure 4. Pretest view of no. 88060; note the absence of crashworthy seat cushion and the dummy PDU and mount.

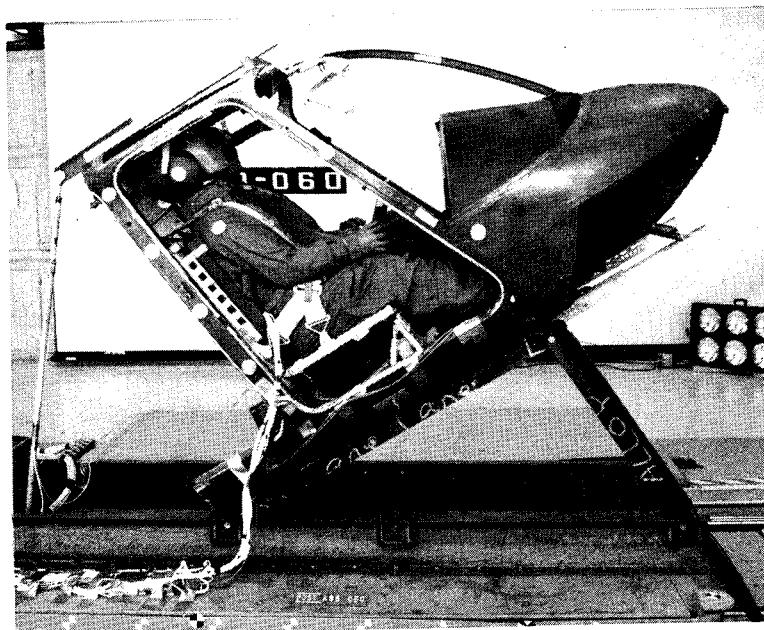
Posttest photos of test 88060 in Figures 4 through 9 show: (a) rotation of helmet rearward on right dummy, but not the left dummy, even though both have equal size 50th percentile heads; the difference may be due to the lack of neck flesh on the Hybrid II (50th percentile) dummy; and (b) the left seat crashworthy seat pan sustained enough downward force from the dummy's buttocks to move the pan down 0.6 inch, and to move the right seat down by 0.3 inch. This was a surprise since the impact vector was 15 G forward, and the seat pans stroke at 12 G vertical. The right seat pan was secured with steel straps to prevent movement in subsequent tests.

Figure 5. Posttest view of no. 88060; note the rearward rotation of helmet after rebound.

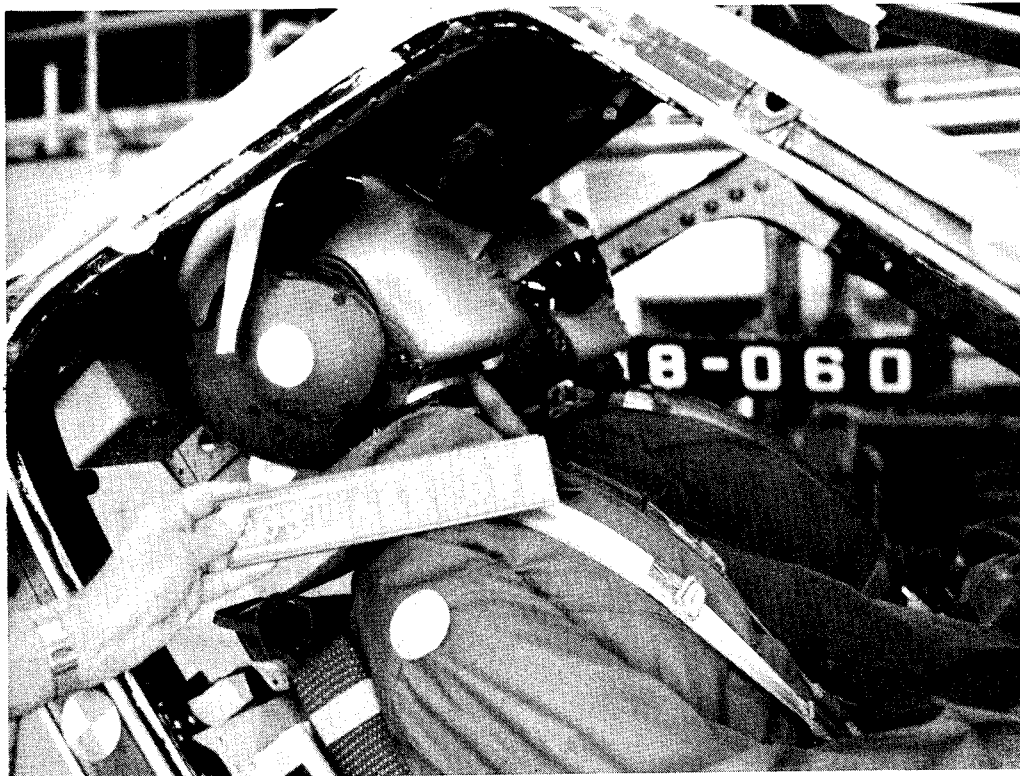
Figure 6. Posttest view of 50th percentile dummy; note helmet rotated until stopped by nape strap.

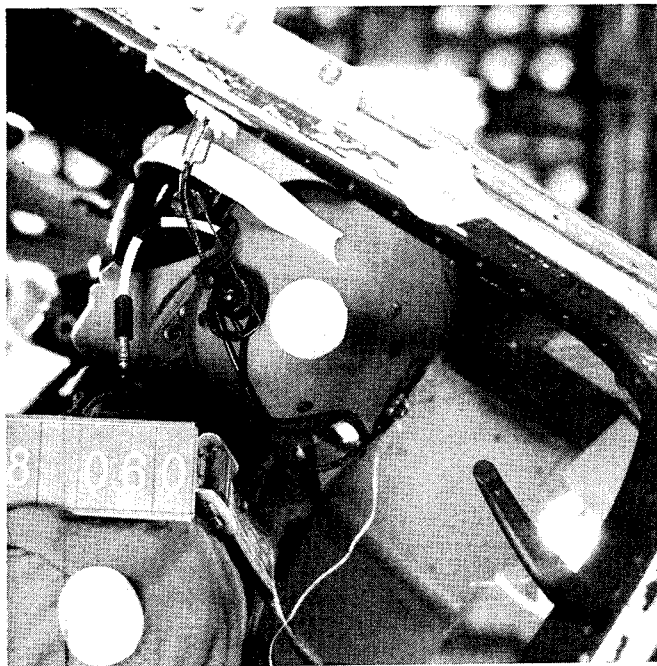
Figure 7. Posttest view of 95th percentile dummy in left seat.

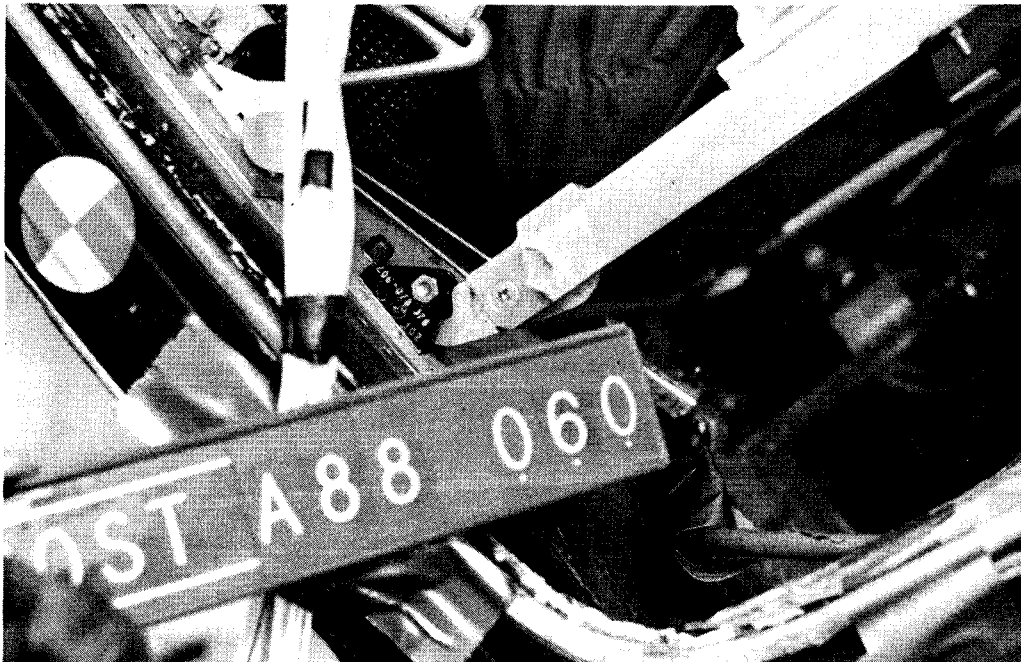
Figure 8. Seat pan downward displacement of 0.3 inch shown between latch and bulkhead support, right side.

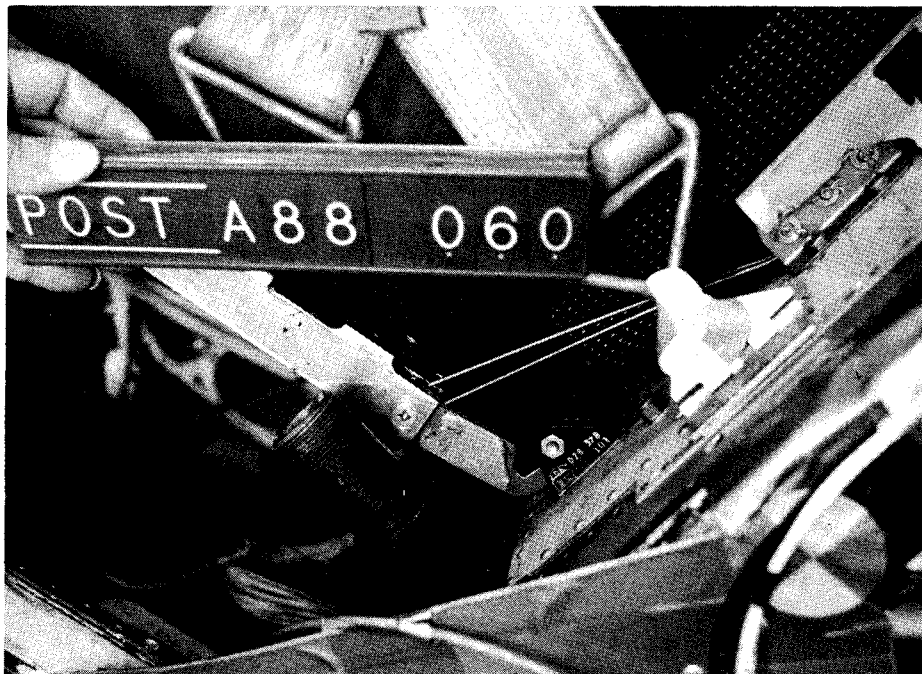
Figure 9. Seat pan downward displacement of 0.6 inch shown between latch and bulkhead support, left side.

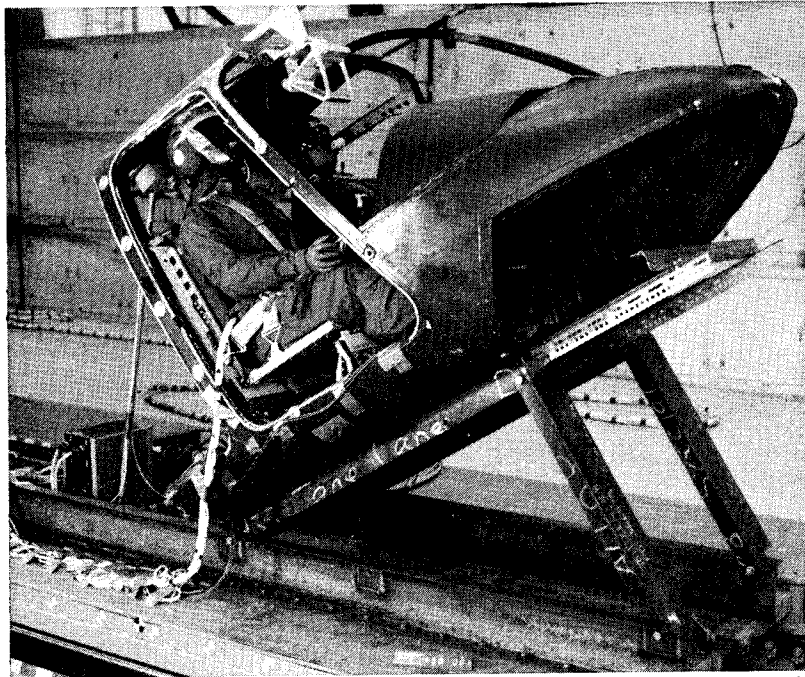
The setup is shown in Figure 10, the straps to secure the right seat are shown along with the reinforcement of the left forward door bulkhead. The posttest photo is at Figure 11.

Figure 10. Pretest view of CAMI 88061; note aluminum strap on inside of left door frame and steel strap on right seat.

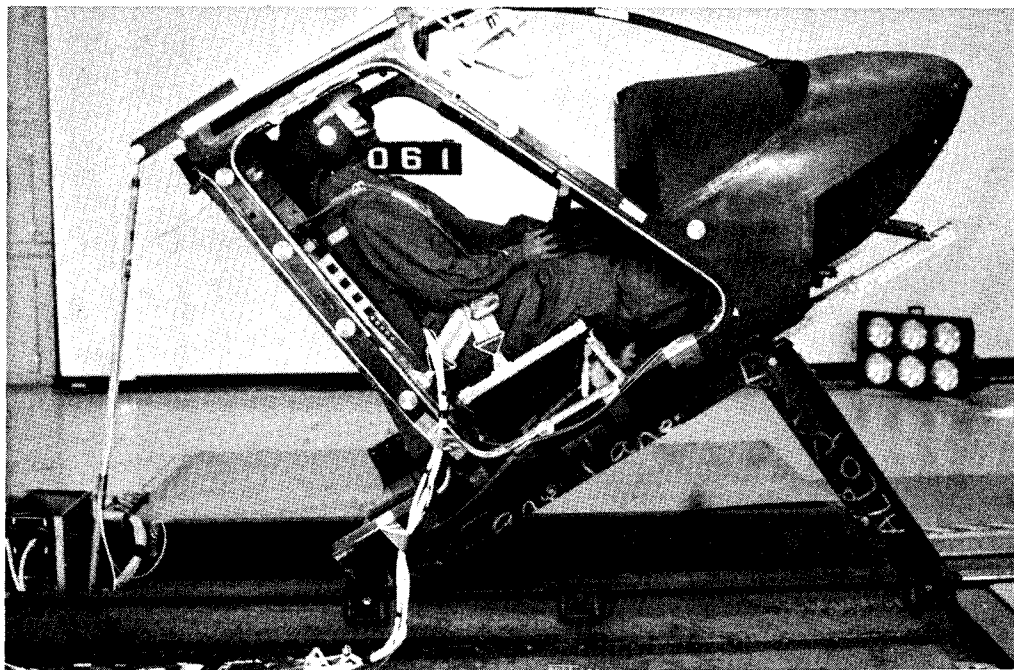
Figure 11. Posttest view of CAMI 88061; note that helmet has not rotated due to tape under chin.

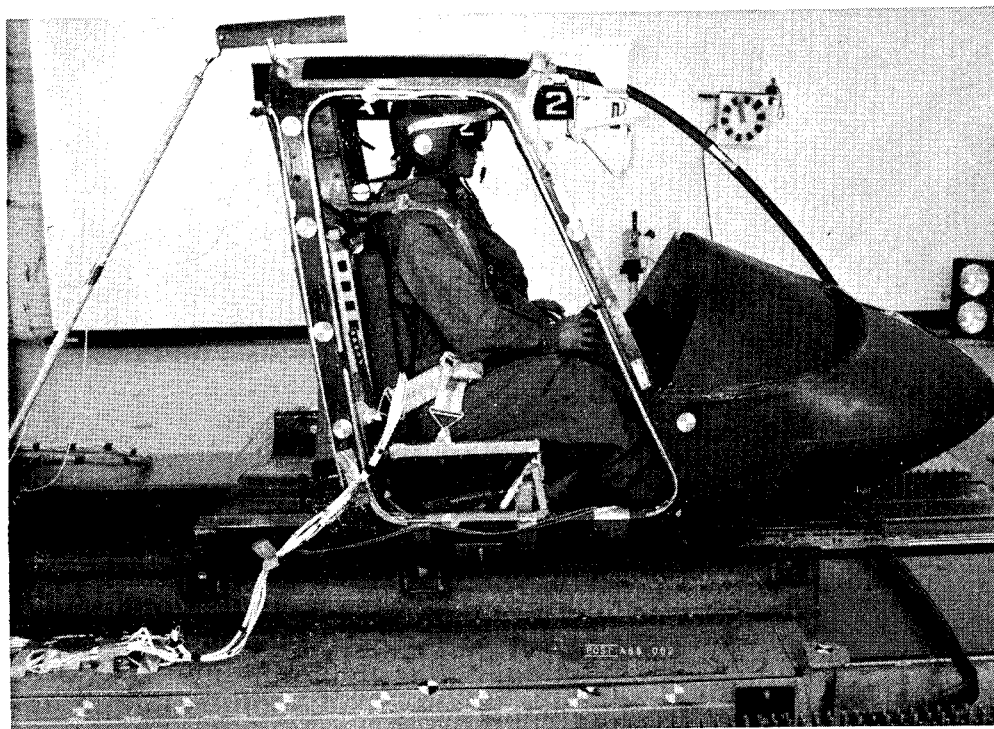
Figure 14. Posttest view of no. 88062; note rebound position of sled about 1 foot from displaced $\frac{1}{4}$ -inch diameter cable.

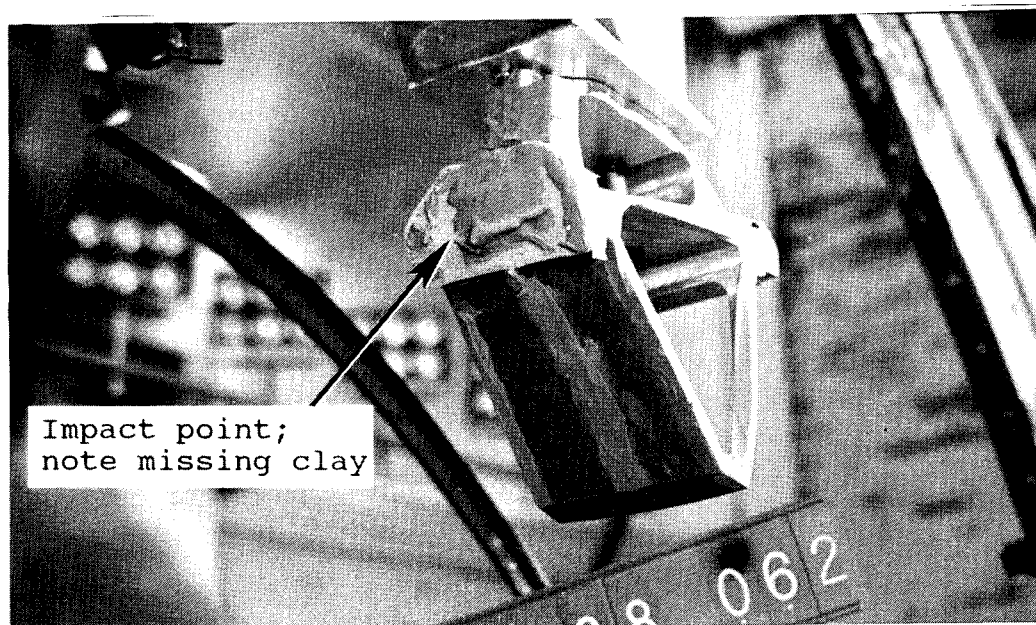
The helmet was replaced after this test due to permanent foam compressive "set" of about 0.05 inch over an area of about 1 square inch in the lower front edge of the foam liner. The foam replacement is required to obtain the full energy-absorbing benefit of the foam liner if impacted again at the same location. The impact location onto the PDU is shown in Figure 15.

Figure 15. Posttest view of no. 88062; note missing clay which was found on helmet of right dummy.

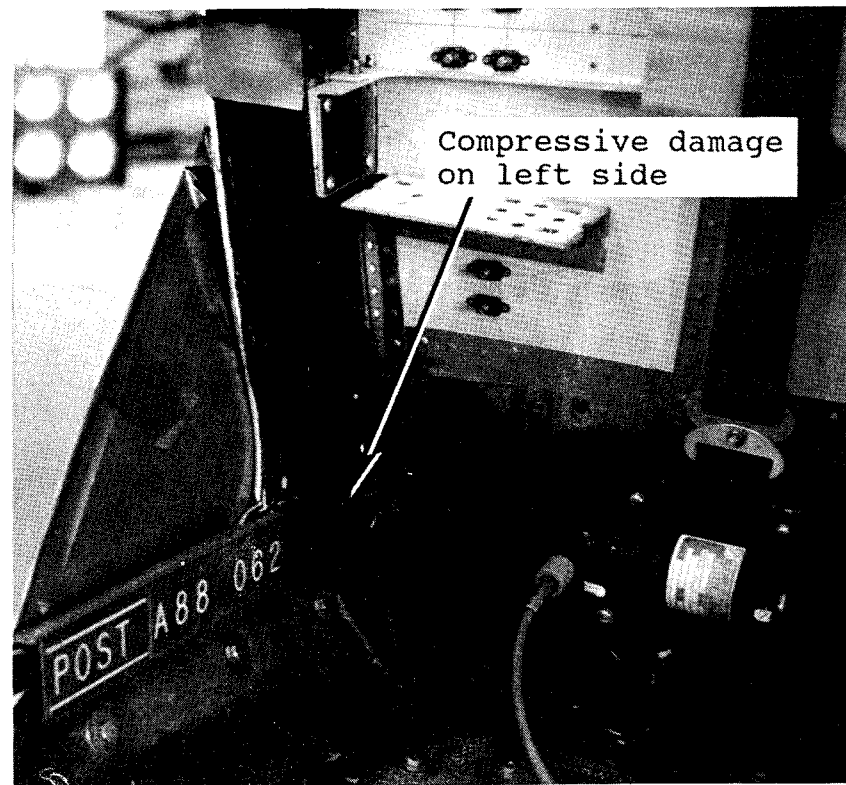
The fuselage station (FS) 73.04 bulkhead was damaged by skin crippling/buckling at the lower outboard edges and at the control "closet" box structure as shown in Figures 16-18. The bulkhead was reinforced prior to the final tests.

Figure 16. Posttest of no. 88062; note buckled "box" section of fuselage station 73.04 bulkhead.

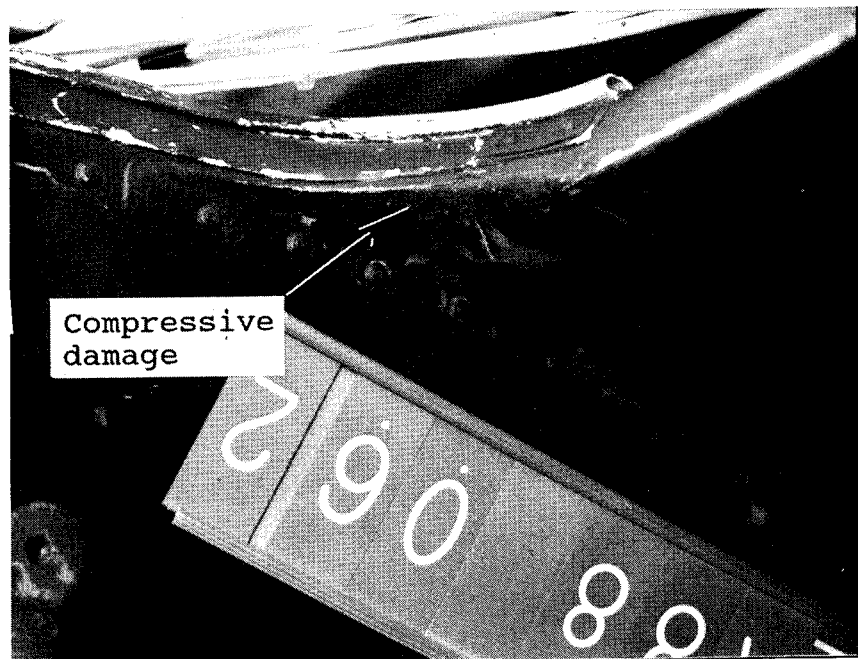
Figure 17. Posttest view of no. 88062; note buckled skin adjacent to "box" section of fuselage station 73.04 bulkhead.

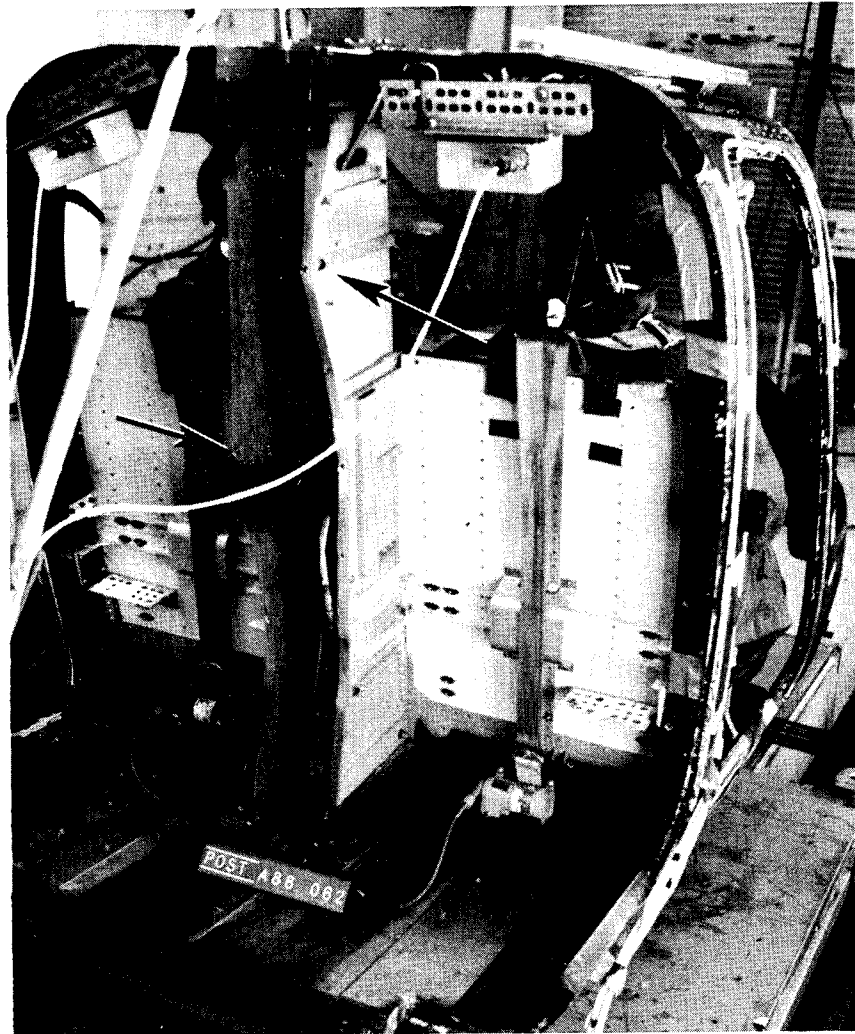
Figure 18. Posttest view of fuselage station 73.04 bulkhead; note buckles in control closet structure by arrows.

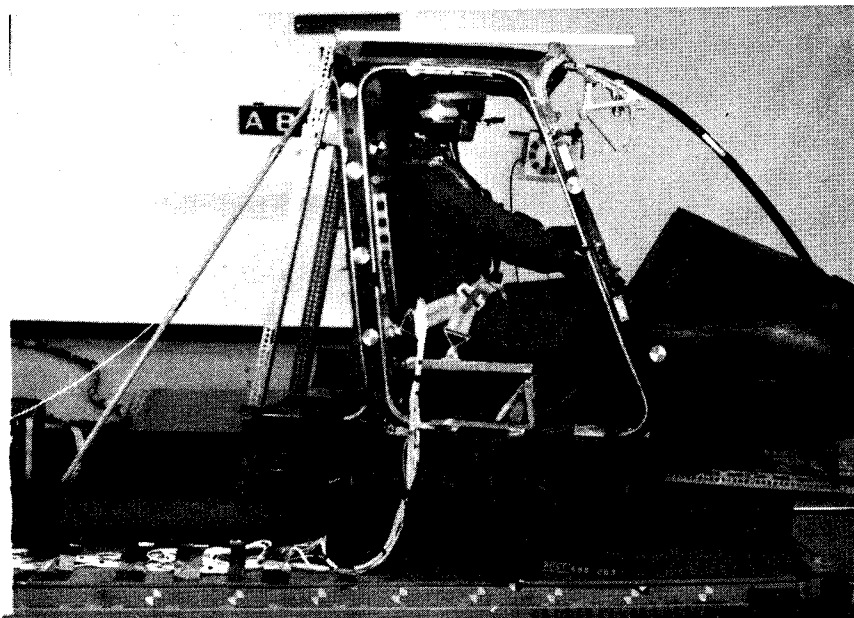
Figure 20. Posttest view of no. 88063; note the actual production PDU mount in place and bulkhead 73.04 reinforcement.

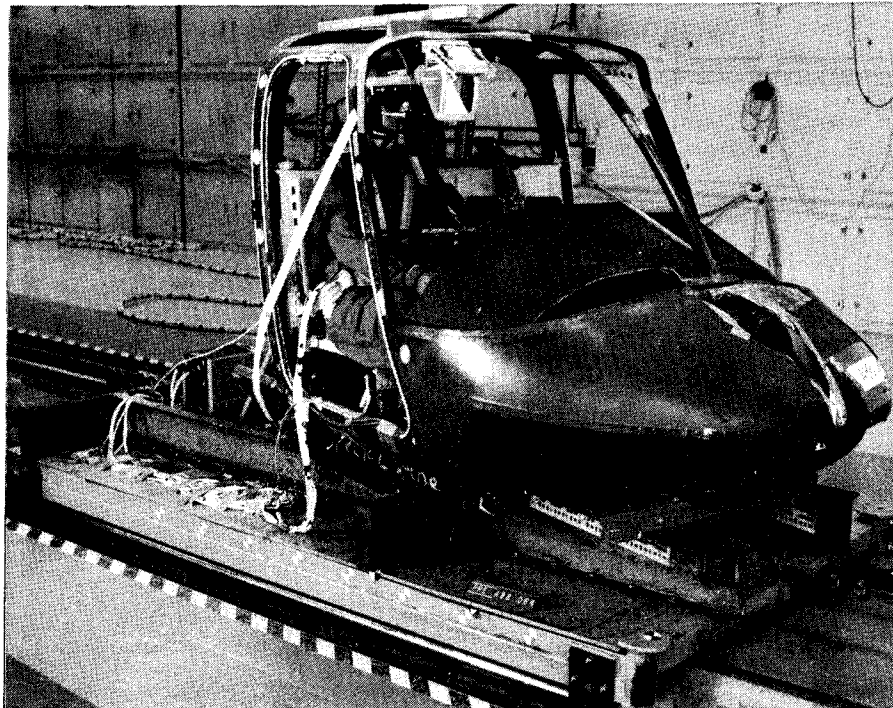
Figure 21. Pretest view of no. 88064; note diagonal aluminum strap added to prevent forward movement of upper door post.

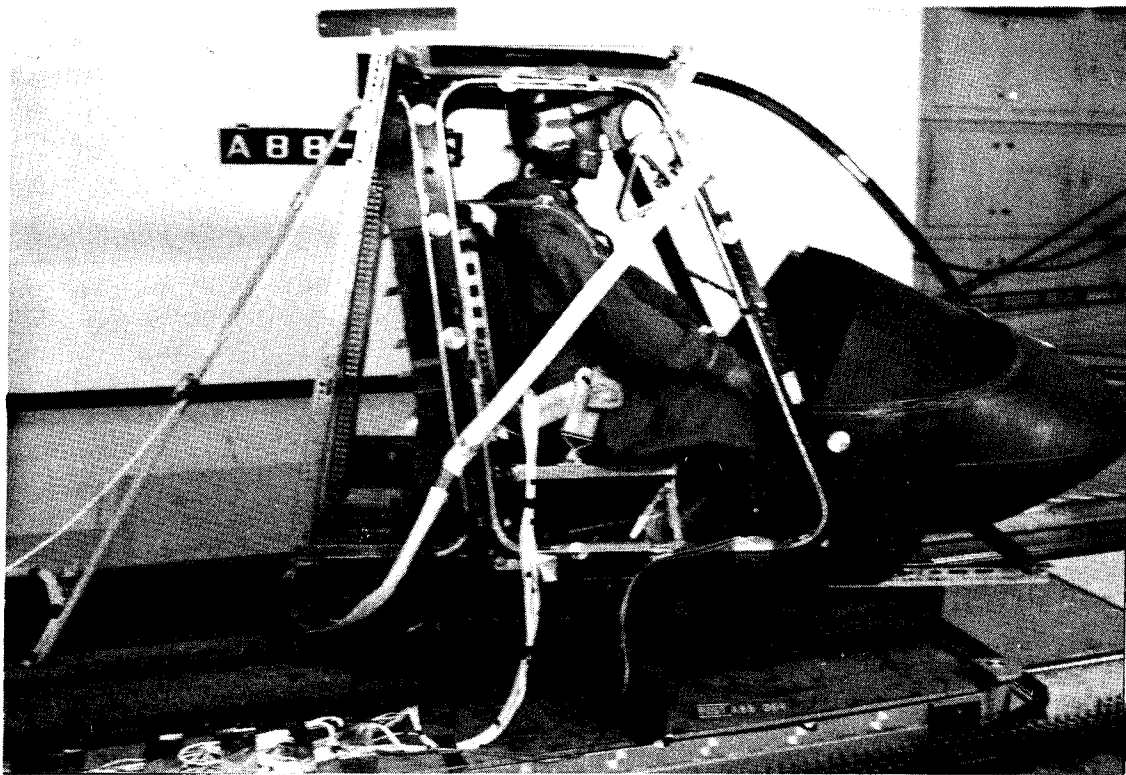
Figure 23. Posttest view of no. 88064; note limp, stretched aluminum diagonal strap, and PDU mount detachment.

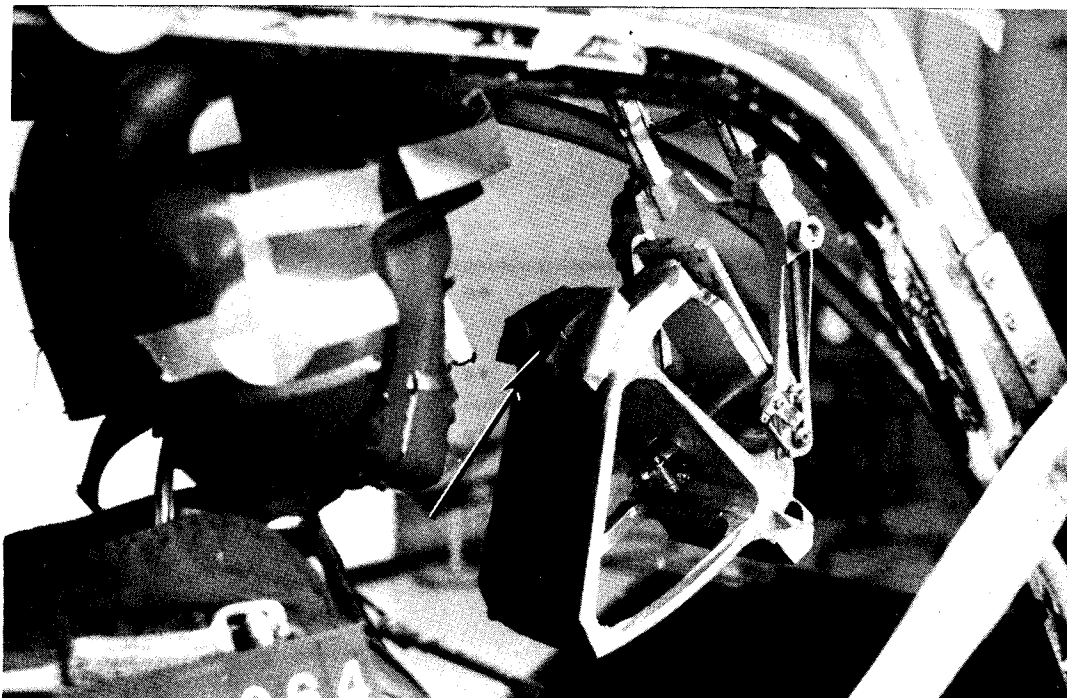
**PDU mount at windshield frame failed partially during rebound, see Fig 24.

Helmet to PDU impact occurred; Figure 31 shows the impact from film analysis. The impact appeared to be severe based on film review since the PDU mount failed at its leading edge rivet attachment to the windshield overhead frame, as depicted in Figures 23, 24, and 26. The impact cracked the helmet visor cover at its center low edge, as shown in Figure 25. The PDU foam also was cracked and the visor cover released the visor knob and visor.

Figure 24. Posttest view of no. 88064; note detached PDU "breakaway" mount and cracked foam at back edge of PDU.

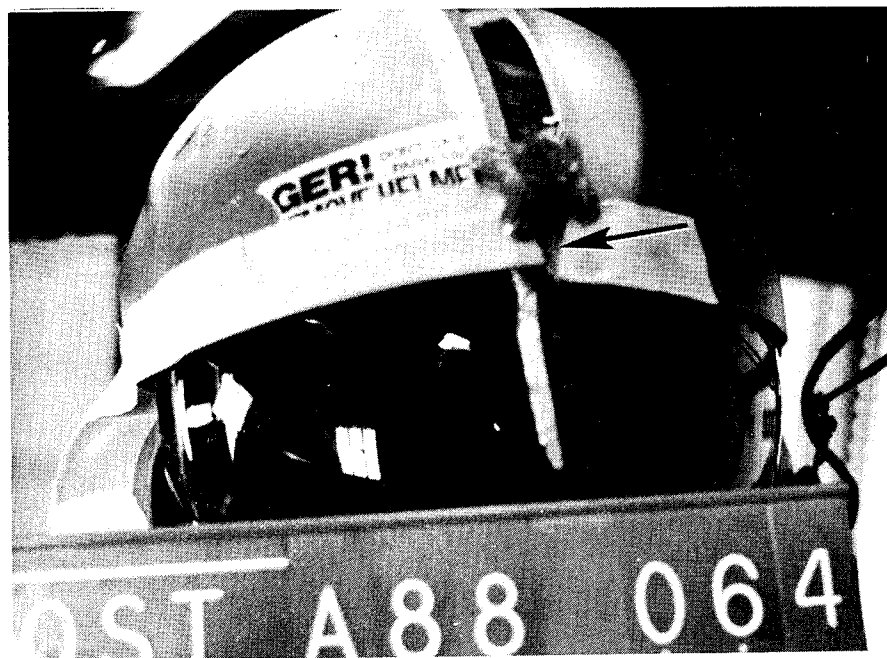
In spite of the damage to the mount and a fracture of the helmet visor cover, the neck force and moment values are less than those recorded in test 88061. Again, the neck transducers show a change in slope of the force and moment curves at approximately 105 ms, the time of the initial helmet impact, and the peak values were less than the prior test where the helmet did not impact the PDU. It is evident that helmet impact against the PDU tends to lower the force and moment in the neck caused by inertial force. Since the helmet prevents excessive head deceleration (from PDU impact), the PDU is not considered a hazard for helmeted pilots.

Figure 25. Posttest view of no. 88064; arrow denotes cracked helmet visor cover.

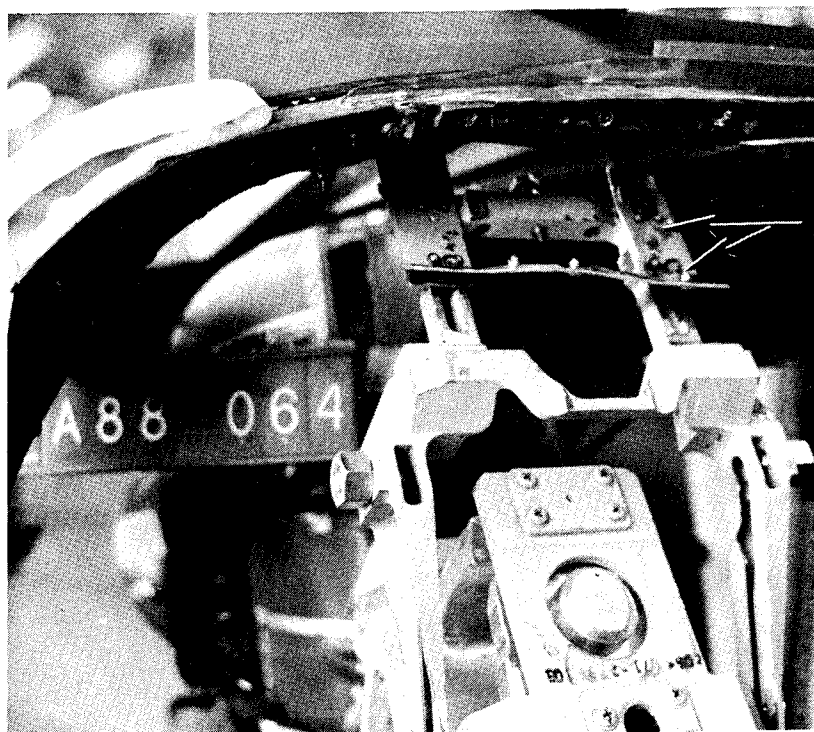
Figure 26. Posttest view of no. 88064; arrow denotes failed rivets which help to secure the PDU breakaway mount.
